TECH TALK: 0070

DIPTRONIC DIP100 / 110 LEAKAGE TEST & PRESSURE TEST

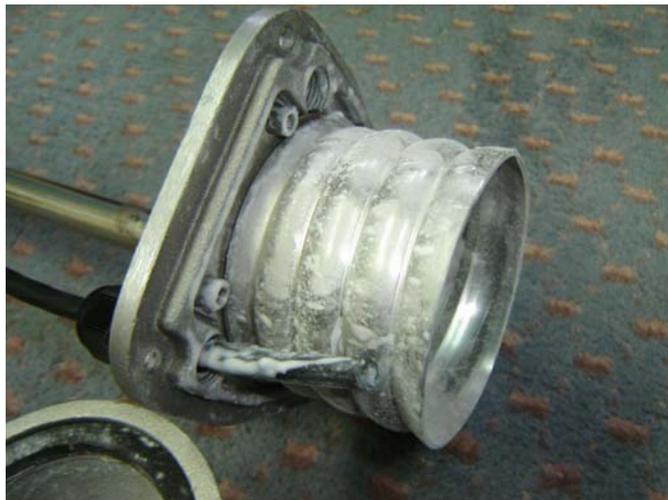
Figure 1

In figure 1, it can be seen that the way the pattern of the powder set around the cable, water ingress was through the gland. This was confirmed on closer inspection, as the gland dome nut was not tightened fully as with the DIP110 unit which was tightened all the way up. This was intentional, since the gland had no specified torque.

- Other unit had dome nut tightened all the way up, did not leak at all. Addressed the issue of having a torque specified. Torque setting to be 3Nm, specified by manufacturer.

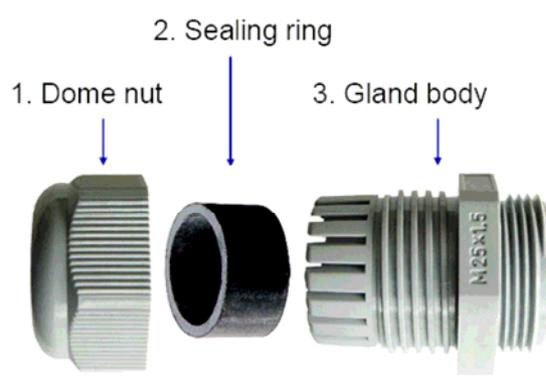
With the DIP110 unit, no leakage was found so it was reassembled. The DIP100 unit was cleaned and reassembled, this time with gland dome nut tightened all the way. The directional water test was then repeated another two times, with no further leaks found.

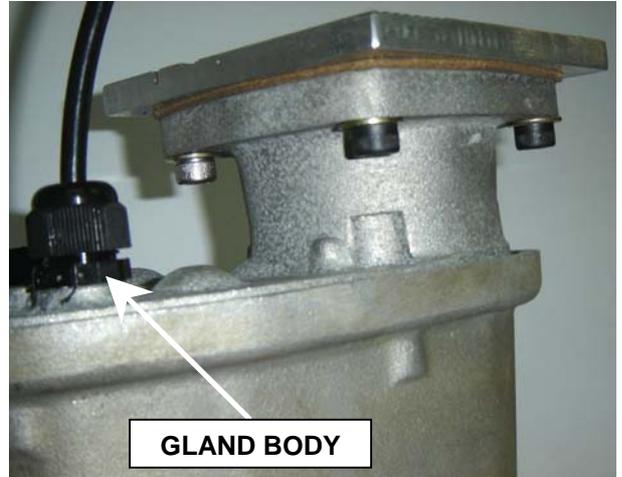
The pressure testing consisted of sealing the base of the unit with a blanking plate and applying air through the gland. This tested both the gland sealing capacity and the porosity of the lid and base. In order to see an air leak, the unit was immersed in a tub filled with water. Evidence of leakage would then show up as bubbles. The gland was tightened to 3Nm; this setting was sourced from the manufacturer of the gland after the initial leak testing stated in the beginning of this report.

From here, air was fed into the sealed unit, as the air was being pumped through a leak occurred where the gland body meets the base. This occurred at 170kpa. Another test with a new gland returned the same result but at 110kpa. Note, at these extreme levels it exceeds the pressure levels that will ever occur in the field.

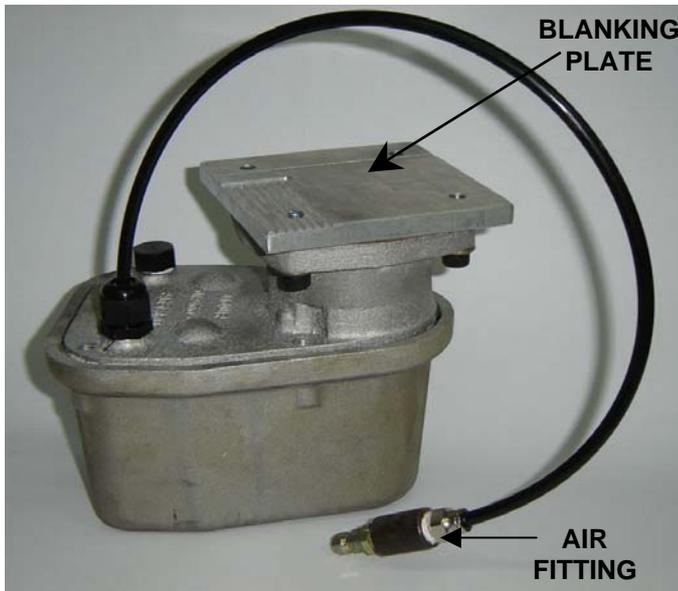
The next test left the unit immersed in the tub water for 5 minutes and setting the pressure to 275kpa. The aim of this test was to test the porosity of both lid and base. Since, it is considered a sealed unit, bubbles would have to form on the surface of the lid or base. Theoretically, a porous material has the tendency to absorb liquid, which also means that if a fluid can penetrate then a fluid can escape. This pressure test did not find any evidence that proved the theory of porosity had a factor in water ingress. To further this, the unit exploded ripping the screws from the threads at approximately 250kpa. This was not intentional, however it did emphasize the sealing capacity of the unit itself.

The pressure test has addressed many theories that have risen from the water ingress issues. Porosity of cast aluminium, the same material of the DIP100 units can be ruled out from these results, since the aim was to see if the lid or base was "breathing" in any way. Nevertheless, we can certainly see that the sealing capacity of the DIP100/110 unit is very high and that assembled with great care, the chances of water ingress is very little to none.
