DIPTRONIC

Software Settings and User Manual

Rev. C

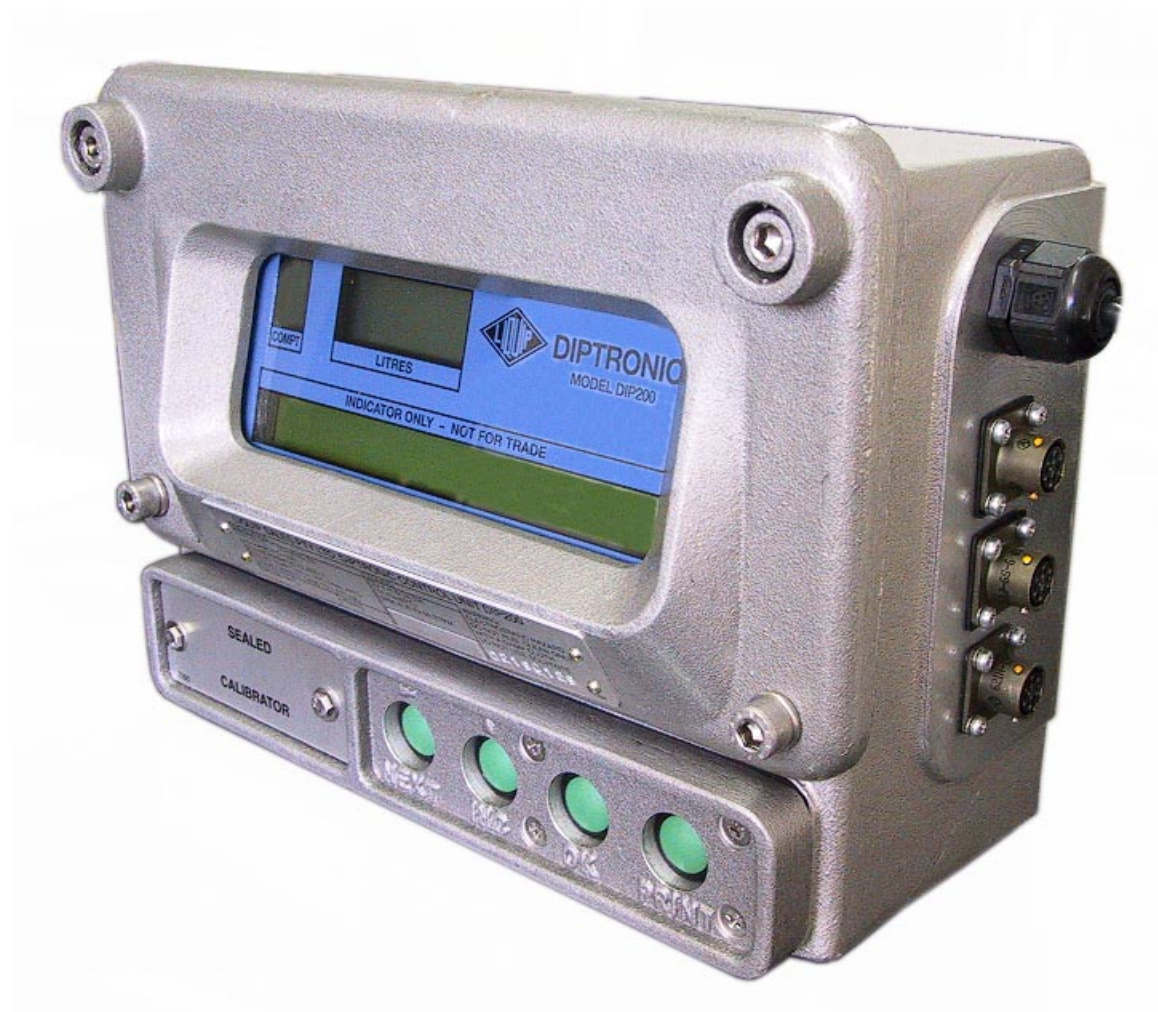
4.1 Display Panel

The Diptronic CPU (DIP200) has two Liquid Crystal Displays:

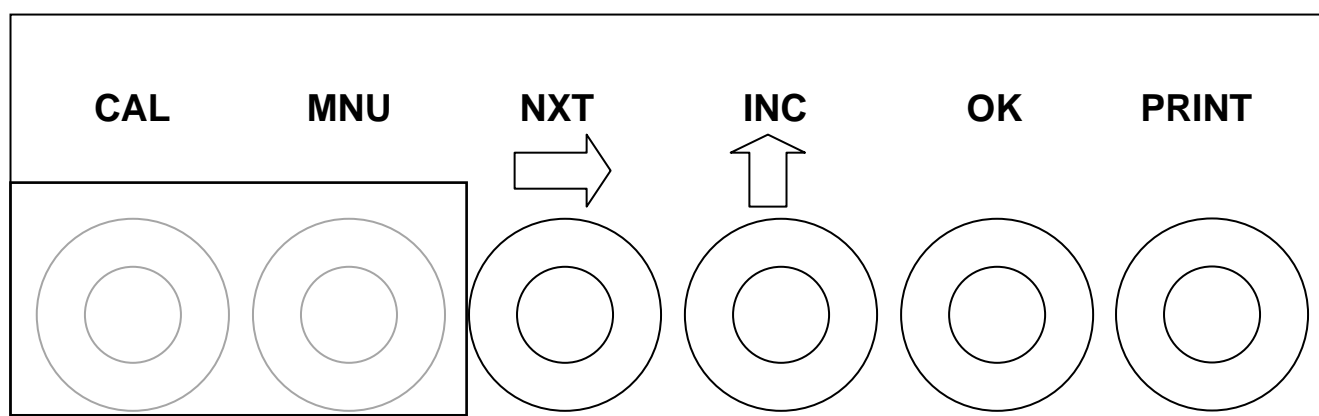
4.2 Keypad Operation in Calibration Mode

The Diptronic CPU (DIP200) configuration is achieved by the two push-button switches under the front security panel and the four front push-button switches each assigned with the following functions:
